Manhole Inspection Summary

Manhole # **S13GG_033MH**

Location Address: **REAR OF 1530 POPLAR GROVE ST** Cross Street: **BAKER ST**

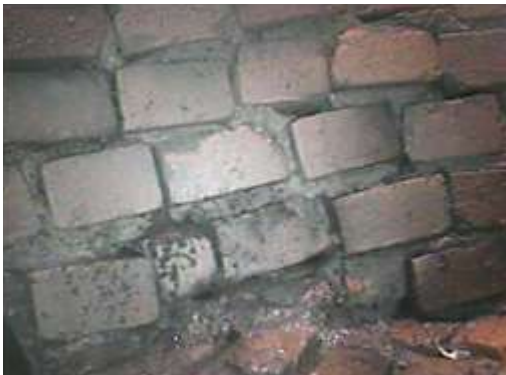
Defect 1

Condition: ☐ Sound ☒ **Cracked** ☐ Root Intrusion ☐ Loose Brick ☐ Deteriorated

Infiltration: ☐ None ☐ Joint ☒ **Cracks** ☐ Mortar ☐ Roots ☒ **Wall**

INFILTRATION AT 8 O'CLOCK

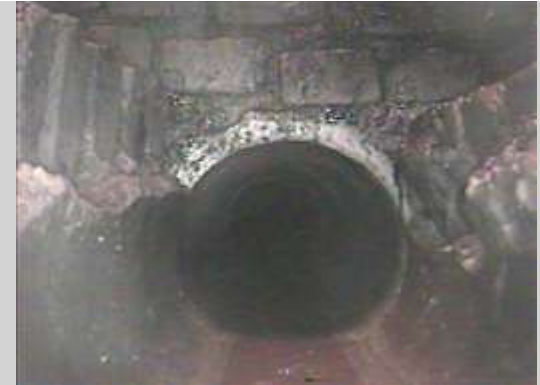
12 O'Clock Outflow

8 in. Circular Gravity Sewer
Pipe Out @ 12 O'Clock

Pipe Height: (in.) Direct
Pipe Material: **Clay** ☐ Pipe Lined
Invert Depth: **9.92** (ft.) Flow Characteristics: **Fast**
Deposits: ☒ None ☐ Mud ☐ Sludge ☐ Debris ☐ Grease
Silt Depth: (in.) Deposits Extent:
Infiltration: **None** Pipe Seal Cond: **Sound**

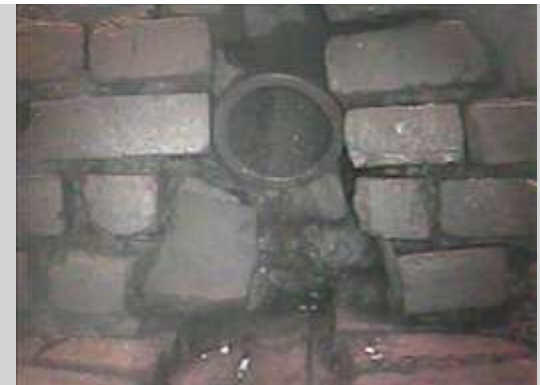
3 O'Clock Inflow

6 in. Circular Gravity Sewer
Pipe In @ 3 O'Clock

Pipe Height: (in.) Direct
Pipe Material: **Clay** ☐ Pipe Lined
Invert Depth: **9.12** (ft.) Flow Characteristics: **None**
Deposits: ☒ None ☐ Mud ☐ Sludge ☐ Debris ☐ Grease
Silt Depth: (in.) Deposits Extent:
Infiltration: **None** Pipe Seal Cond: **Sound**

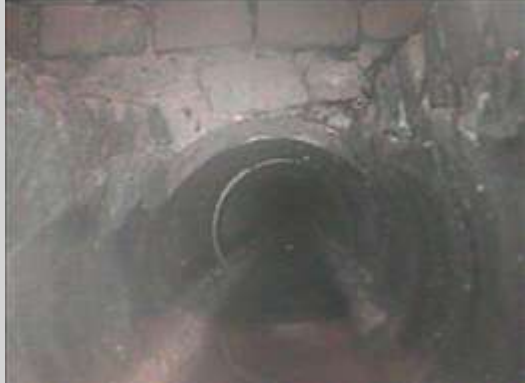
6 O'Clock Inflow

8 in. Circular Gravity Sewer

Pipe In @ 6 O'Clock

Infiltration: **None** Pipe Seal Cond: **Sound**

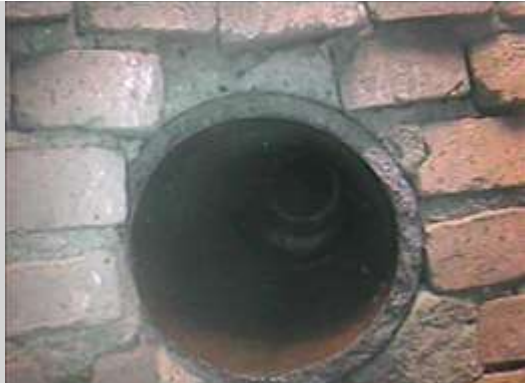
9 O'Clock Inflow

Pipe In @ 9 O'Clock

INFILTRATION AT 8 O'CLOCK

Infiltration: **None** Pipe Seal Cond: **Sound**

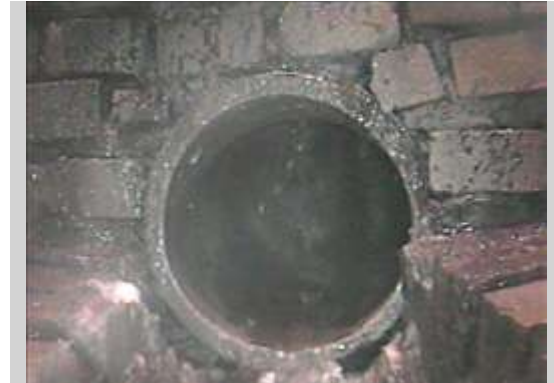
Drop In @ 9 O'Clock

INFILTRATION AT 8 O'CLOCK

Drop: **Outside Direct**

Drop Condition: **Open**
